GRYPHON REQUEST FOR INSPECTION

Climbing Technology has issued a voluntarily request for inspection of the Gryphon (Ref. No. 7H174) and Gryphon Ascender (Ref. No. 7H178) full body harnesses by the user.

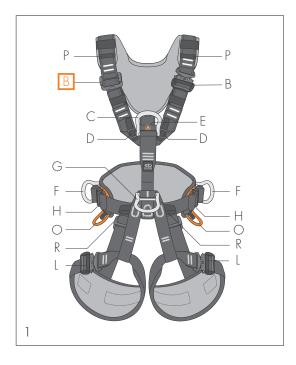
It has come to our attention that there might be the possibility of a miss-threaded shoulder strap in the adjustment buckle B (Figure 1). This error can lead to difficulties in the adjustment of the harness.

Because of this, when donning the harness, the shoulder strap can easily loosen making it impossible to correctly adjust the harness. To date, only one harness with this issue has been identified and no accidents have been reported.

We ask you to carry out the inspection procedure indicated below. If the product in your possession is affected by this problem, please contact us to arrange shipment at our expense:

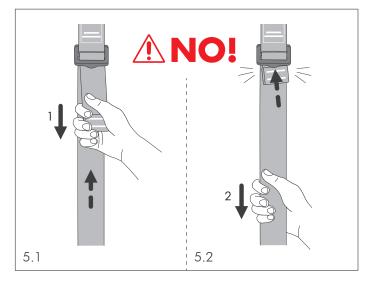
- 1) Pull the outer part of the strap (Fig. 4.1-5.1);
- 2) After that, pull the inner part of the strap (Fig. 4.2-5.2):
- if the strap remains stable in its position, the adjustment
- system is working correctly (Fig. 4.1-4.2); if the strap is free to move inside the adjustment system, the buckle is affected by the error (Fig. 5.1-5.2). Stop using the harness and follow the instructions indicated on the previous page.
