Structural Sewing Inspection Sheet - Viper 2 & Vixen Harness

This sheet refers to Viper 2 and Vixen harnesses:

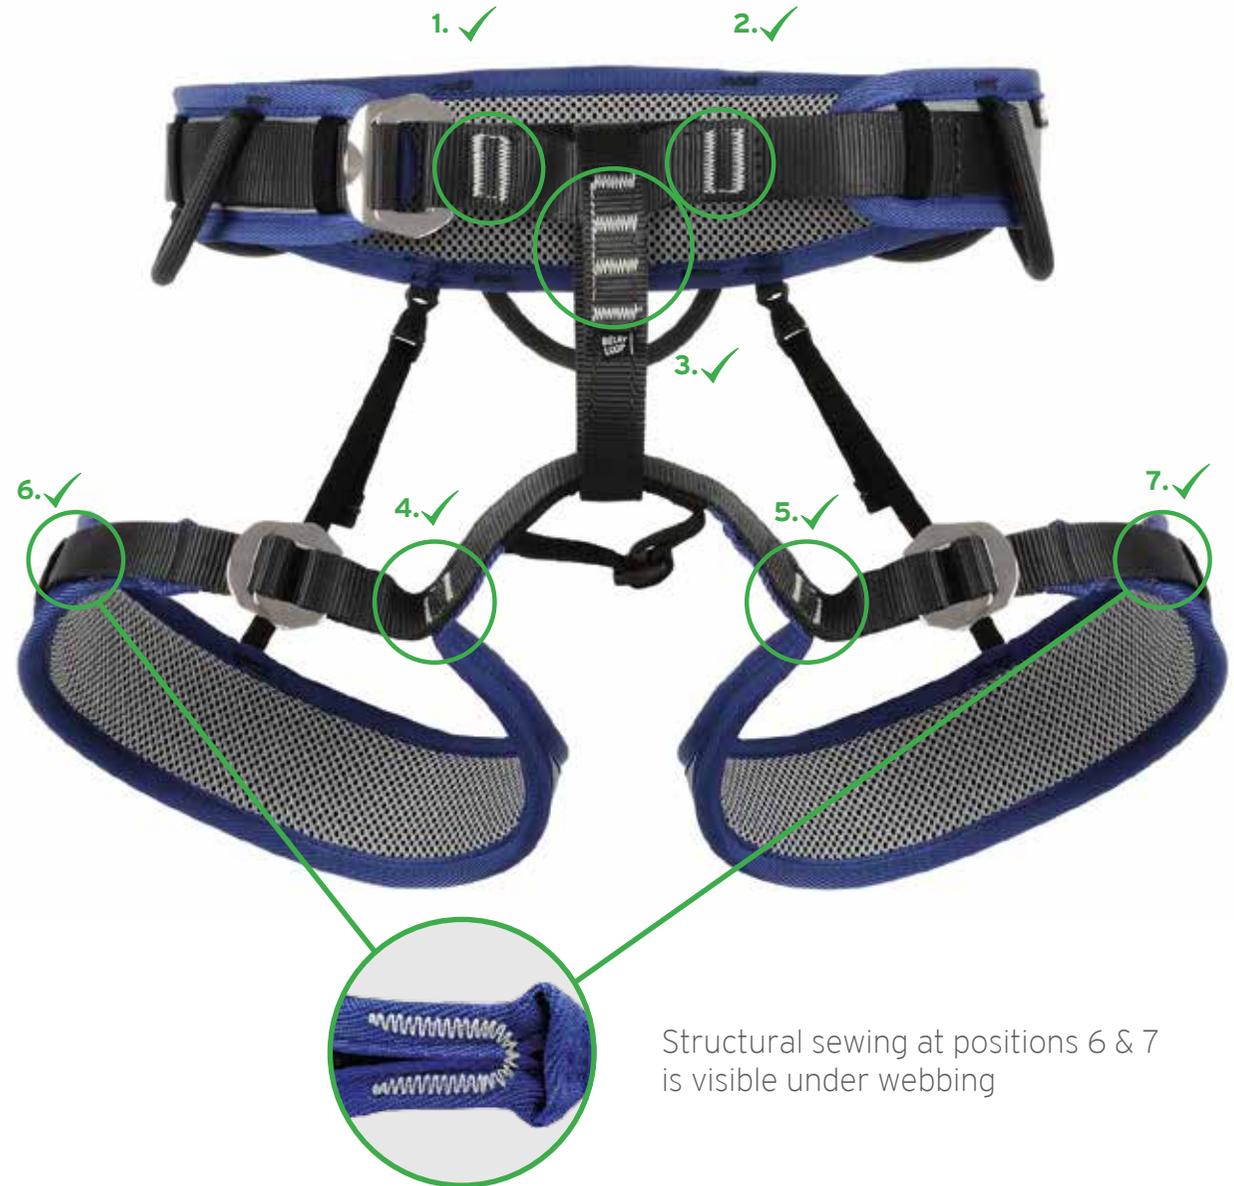
The image of the harness shows all structural sewing present and correct, highlighted by the green circles.

The red circle below shows an example of missing structural sewing.

Structural sewing at positions 6 & 7 is visible under webbing

If structural sewing is missing stop use and contact DMM:
