User Inspection Notice –SH903x and SH905x

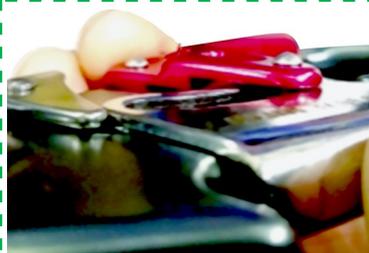
Whilst there have been NO reports of accidents or injuries we have recently become aware of a situation with a Snaphook where the second-action keeper interfered with the third-action catch. Initial observations point to deformation of the second-action keeper (damaged through external forces) allowing it to incorrectly engage with the third-action catch. The second-action keeper was deformed (splayed out) in a way that allowed it to travel through its normal plane without the third-action catch first being depressed (see Figure 1). This allowed the gate to open, without the need to utilise the two deliberate actions normally required to open this device.

Figure 1—If there is evidence of deformation (see arrow) then you **MUST** retire the unit.

RETIRE

Users must continue to conduct regular inspections (at least daily) to ensure that the product is in a serviceable condition, ensuring all moving parts do move correctly especially any locking mechanisms. Inspect the mechanism for wear or abnormality, paying particular attention to the interaction between the second and third-action mechanism—see photographs shown on page 1.

ISC Snap hooks SH903x and SH905x are **safe for continued use** once your daily PPE inspection proves the normal operations of the gate mechanisms, and shows no evidence of detrimental wear or damage to these mechanisms. Should any doubt arise regarding its condition for safe use, the product should be immediately withdrawn from use and not used again until confirmed in writing by a competent person that it is safe to do so.
