PRODUCT RECALL - WIZARD PRO (REF. 3500) AND WIZARD PRO BLACK (REF. 350003) DESCENDERS

During quality control procedures, C.A.M.P. identified a potential tolerance defect in the internal mechanism of the Wizard Pro (ref. 3500) and Wizard Pro Black descenders.

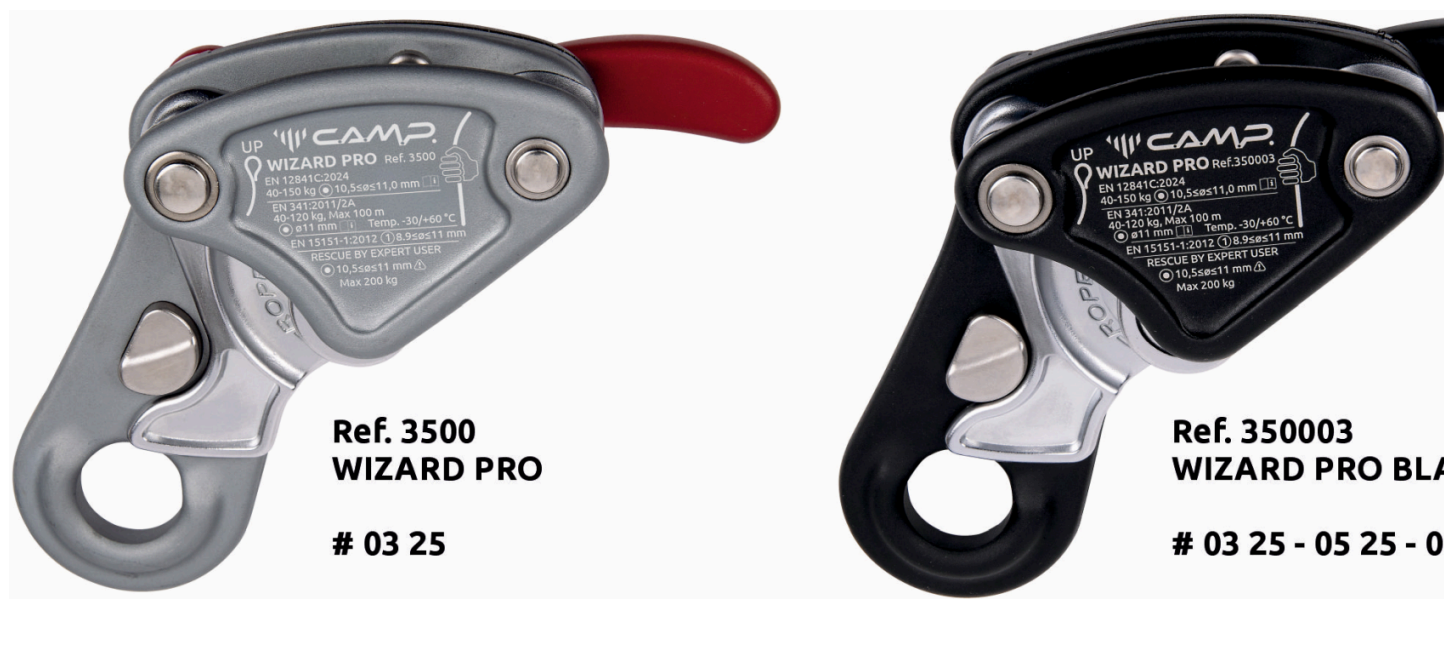
This defect may lead to the locking cam jamming in the open position, resulting in a potential uncontrolled descent and fatal consequences.

- Ref. 3500 Wizard Pro: batch 03 25.
- Ref. 350003 Wizard Pro Black: batches 03 25, 05 25, 01 26.

- Immediately stop using the Wizard Pro and Wizard Pro Black descenders and check the batch number.

- Return all descenders with the specified batch numbers. The descenders can be returned to the store where they were purchased, to a C.A.M.P. subsidiary distributor in your country, or sent back – at our expense – to C.A.M.P. SpA. We will repair the returned products and send them back as quickly as possible.

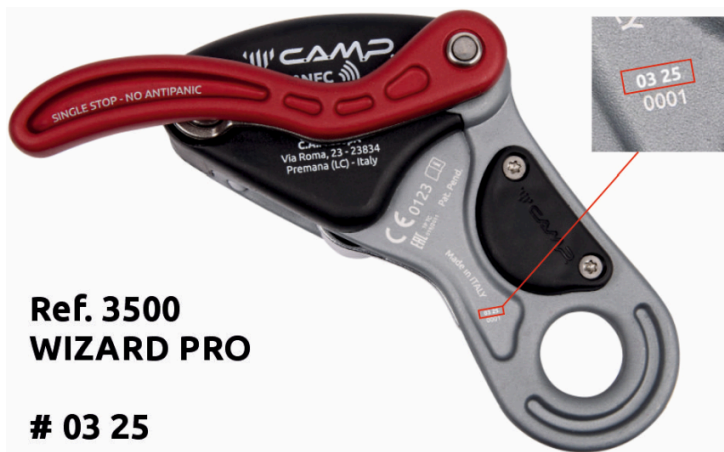
**Ref. 3500
WIZARD PRO**

The batch number is visible on the back of the descender, marked on the rear aluminum flange:

03 25

An "R" letter will be engraved on the descender next to the batch number (e.g., 03 25 R) on all units repaired by C.A.M.P.

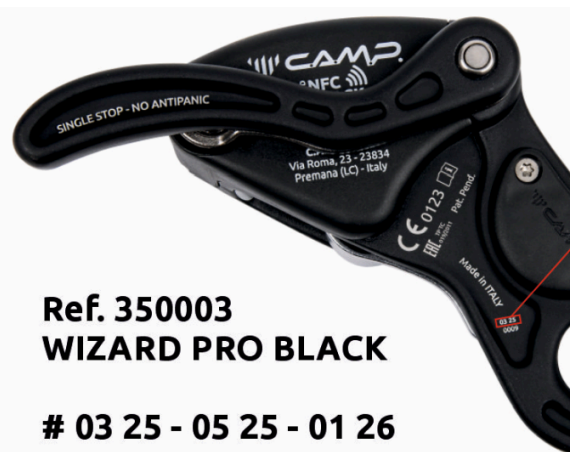
**Ref. 350003
WIZARD PRO BLACK**

03 25 - 05 25 - 01 26
